REHABILITATION STUDY REPORT

BRIDGE NO. 01349

Route 136 over Saugatuck River

Town of Westport

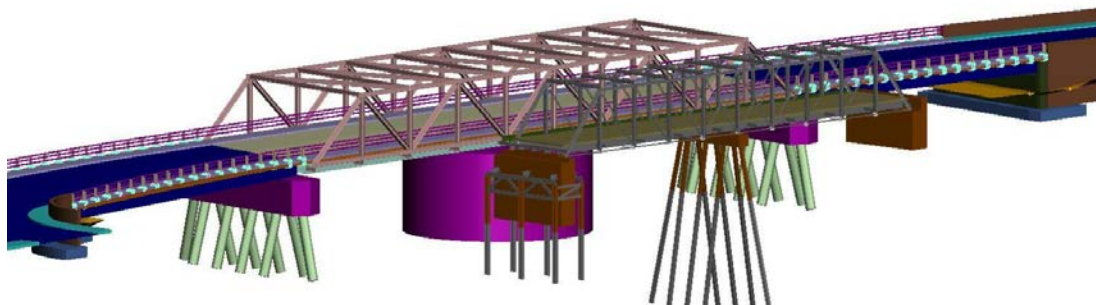
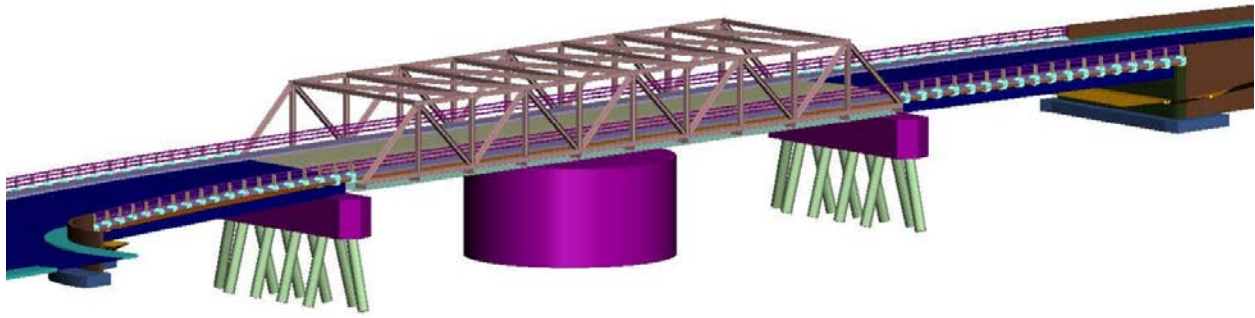
The structure proposed is for comparative purposes only. Should a bridge replacement option be selected, a structure-type study would determine the actual bridge type to be selected and the geometry and lane capacity. For relative location comparison, the structure modeled for this report is depicted below, first with the existing fixed spans shown, followed by a depiction of just the replacement bridge.

Construction of the proposed off-alignment replacement bridge is anticipated to take approximately 2.5 to 3 years, including two winter shutdown periods, and vehicular and pedestrian traffic would be maintained throughout construction on the existing bridge.
